Fastener Manufacturer Tightens Roofing System Performance

Roof Asset Management Highlights

Facility Background

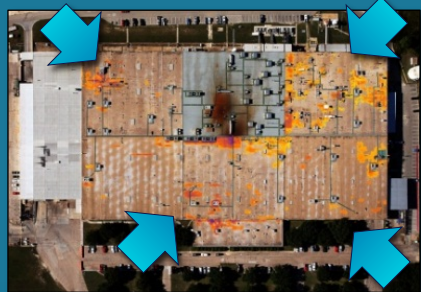
Aerial Infrared Pinpointed Hidden Moisture

RAM's comprehensive condition assessment quickly baselined the roof and building envelope performance. Aerial infrared identified moisture hidden in the roofing system. The onsite engineering and diagnostic condition assessment evaluated the roofs, walls, structural systems, and fall protection safety exposures. The final results helped win support and funding for resolving the building's performance issues.

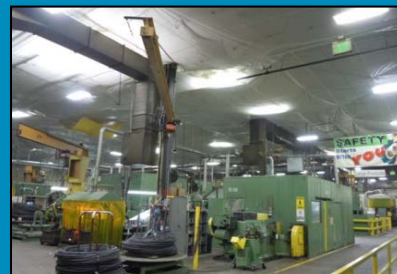
Interior Protection

- Installed 1500lb Rated-Netting and 6mil Poly Interior Protection Ensured Continued Safe and Reliable Plant Production
- Installed Temporary Fall Protection to Ensure Contractor Safety During Demolition and Installation
- Helicopter Lift and Replacement of 45 HVAC Systems on New Curbs
- Removed Old Roof and Installed New R-22 Built-up with Flood Coat & Gravel Roofing System
- Installed Engineered, OSHA Compliant, Permanent Fall Protection Systems
- Provided a 15 Year Warranty and Maintenance Inspection Program
- Project Safely Completed On Time and On Budget
- Plant Maintained 100% Production During Roof Replacement Project

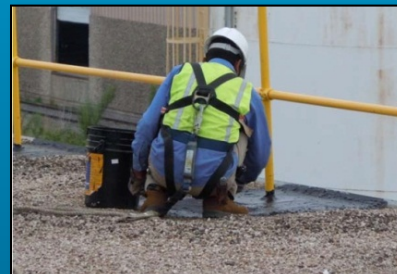
Permanent Fall Protection

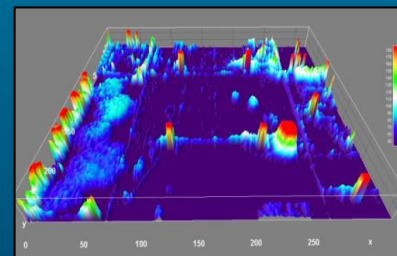
Energy Modeling

Sustainability and energy optimization are key components of success for meeting the client's corporate mandates. The new roofing system increased the R-value from an R2 to R22. RAM's energy modeling incorporated the building's thermal performance, ASHRAE / DOE criteria, and Client climate/energy data to determine that the upgraded roofing systems will save the facility over \$18 Million in energy costs over the next 20 years...more than paying for the surveys, design, new roofing system materials/installation, safety and interior protection costs!
